# Mater Hospitals, Brisbane. Mater Private Clinic.

A milestone was reached in the \$220M Stage 2 redevelopment of the Mater Hospital at South Brisbane with the erection of four giant support trusses. The steel trusses each weigh 40 tonnes and bridge 31m across the air space above Water Street, supporting a three storey sky-bridge structure which forms the Link Building component of the now completed Mater Private Clinic which joins the Mater Private Hospital.

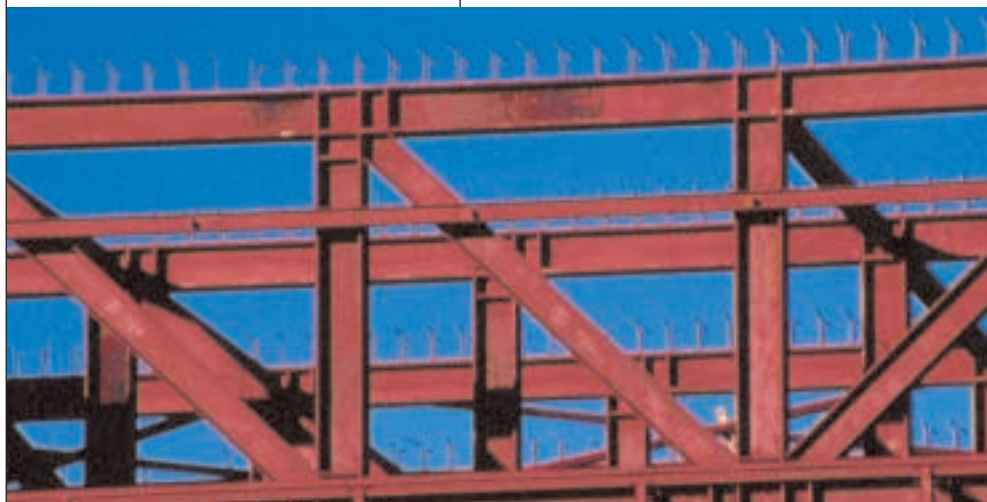
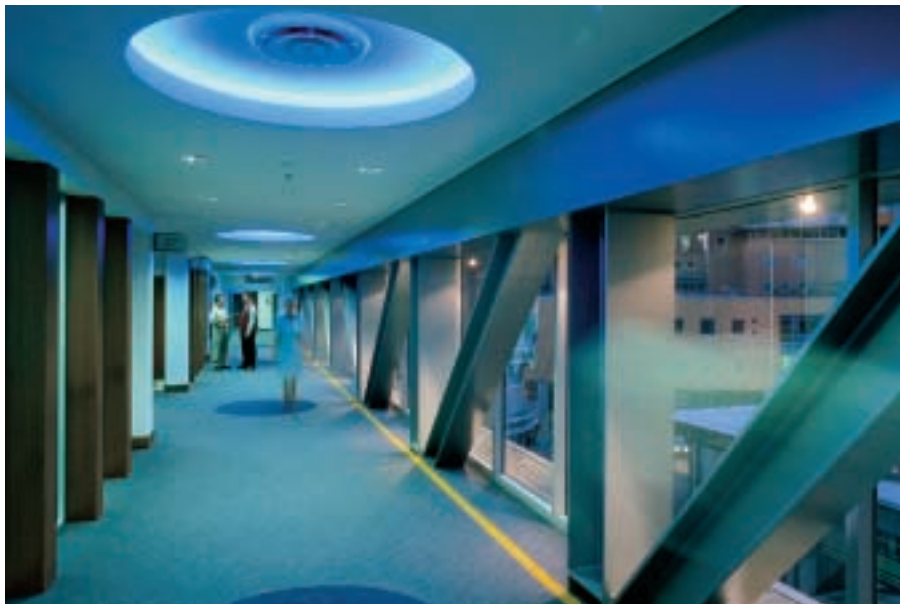
Truss details are listed below:-

- Span : 30.6 metres
- Length : 35.6 metres
- Depth : 3.65 metres
- Spacing : 7.20 metres
- Member Sizes
  - Top Chords : 400 WC sections
  - Bottom Chords : 400 WC sections
  - Vertical Web Members : 400 WC sections
  - Diagonal Web Members : 400 WC sections & 310 UC sections
- Steel Grade
  - Top & Bottom Chords : Grade 400
  - Web Membranes : 300PLUS®

Preference in the choice of truss member sizes was given to members with low surface area to mass ratios, which assisted in eliminating the need for passive fire protection of the trusses. This was beneficial in reducing the cost of the trusses and in achieving tight program requirements for construction.

Schmider Engineering Group fabricated the four steel trusses (total weight 140 tonnes) as well as the floor beams and bracing (total weight 20 tonnes). The trusses were transported to site in one piece and were erected by a Brambles 330 tonne SWL mobile crane. The trusses were erected without incident and only minimal adjustments on site were required.
